RESEARCH MEMORANDUM

FLIGHT MEASUREMENTS OF THE LONGITUDINAL STABILITY AND CONTROL

CHARACTERISTICS OF THE GRUMMAN F8F-1 AIRPLANE --

TED NO. NACA 2379

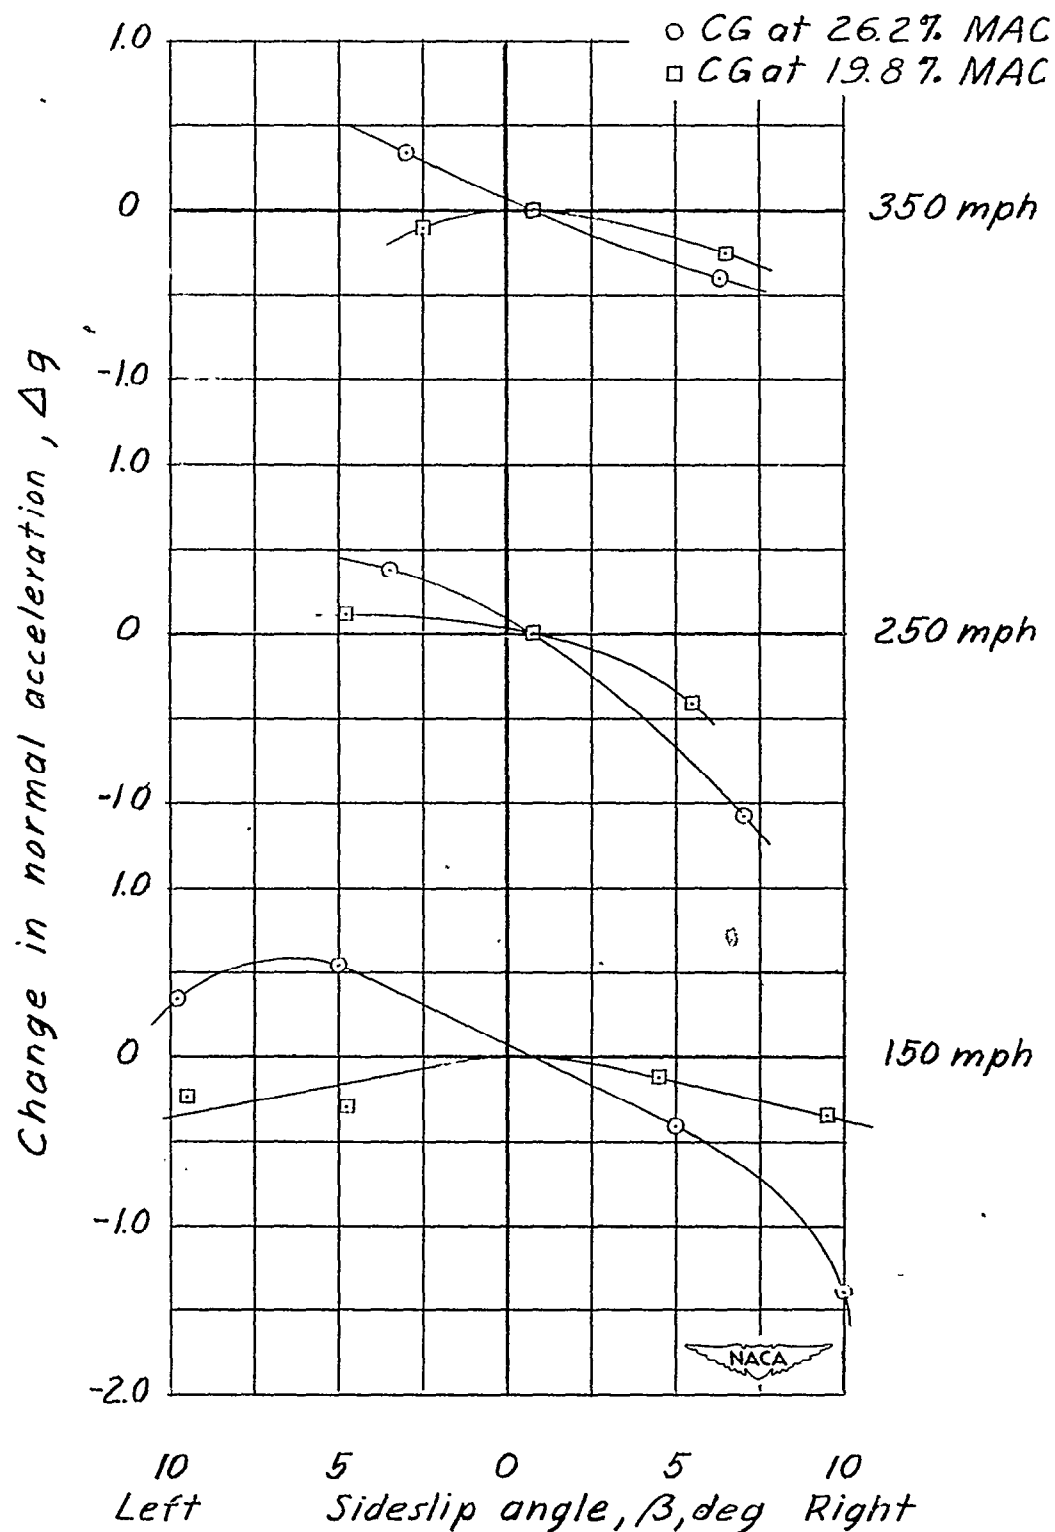
Figure 19.- Summary plot of the change in normal acceleration against sideslip angle obtained in releases from steady sideslips. Grumman F8F-1.

Pitching moment due to sideslip.- In the course of making rudder kicks and control releases from steady sideslips, the test pilot noticed changes in longitudinal trim causing the airplane to pitch. His findings were verified from a study of the test results which showed appreciable changes in normal acceleration and pitching velocity. To ascertain the extent of these effects, a few additional tests were made and the results plotted in figures 16 to 19. Typical time histories of oscillations

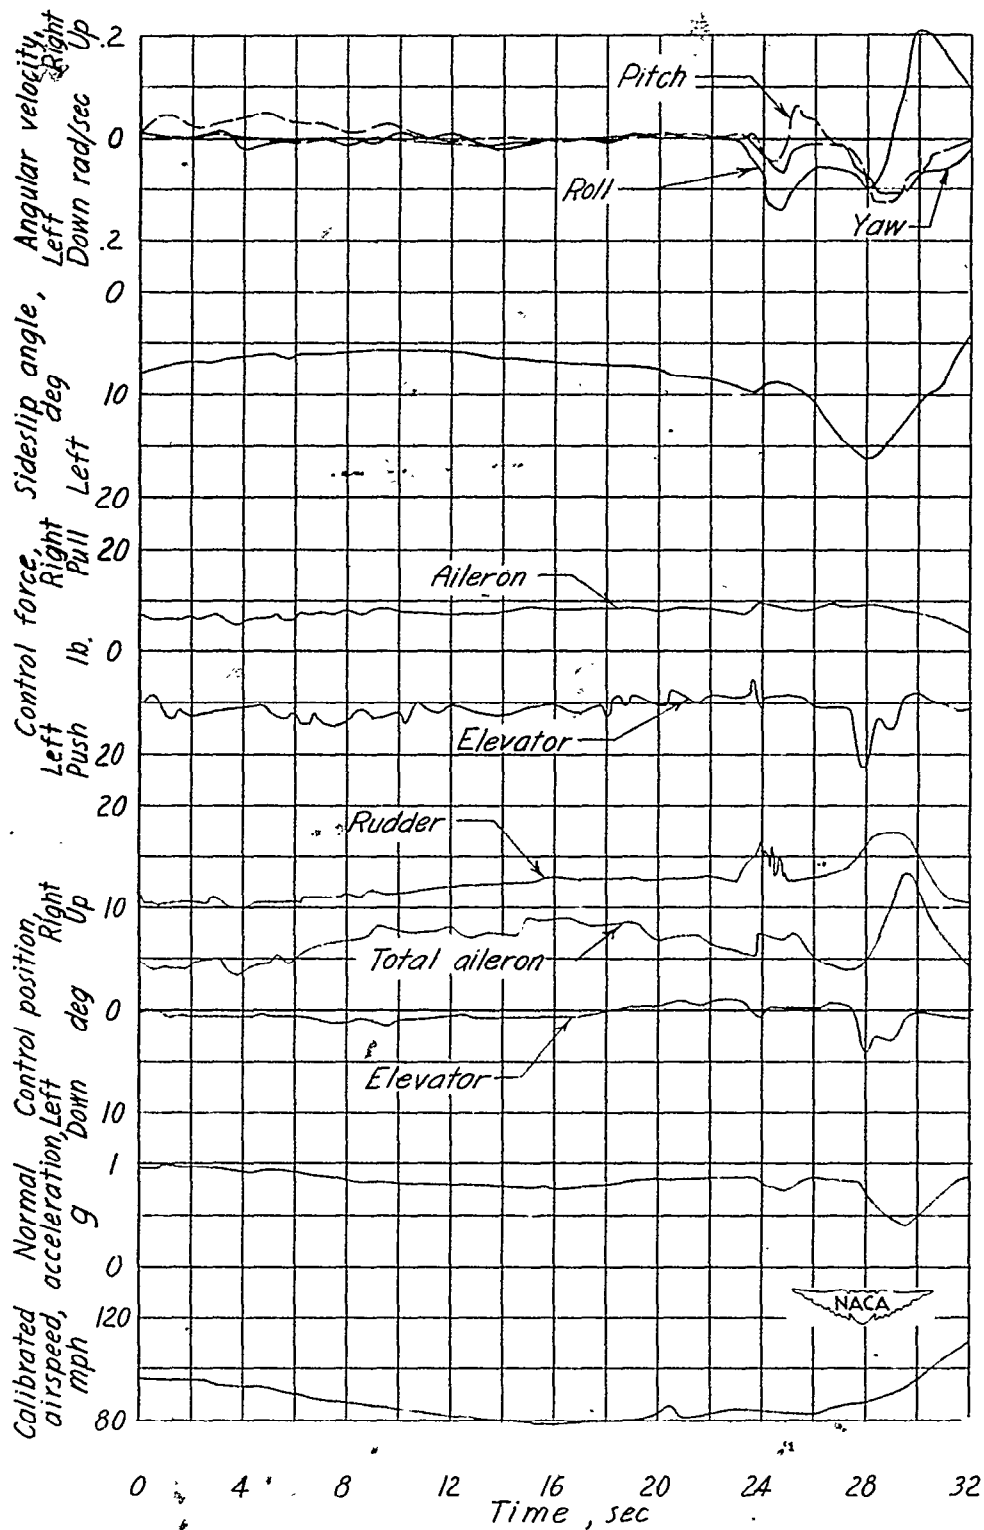
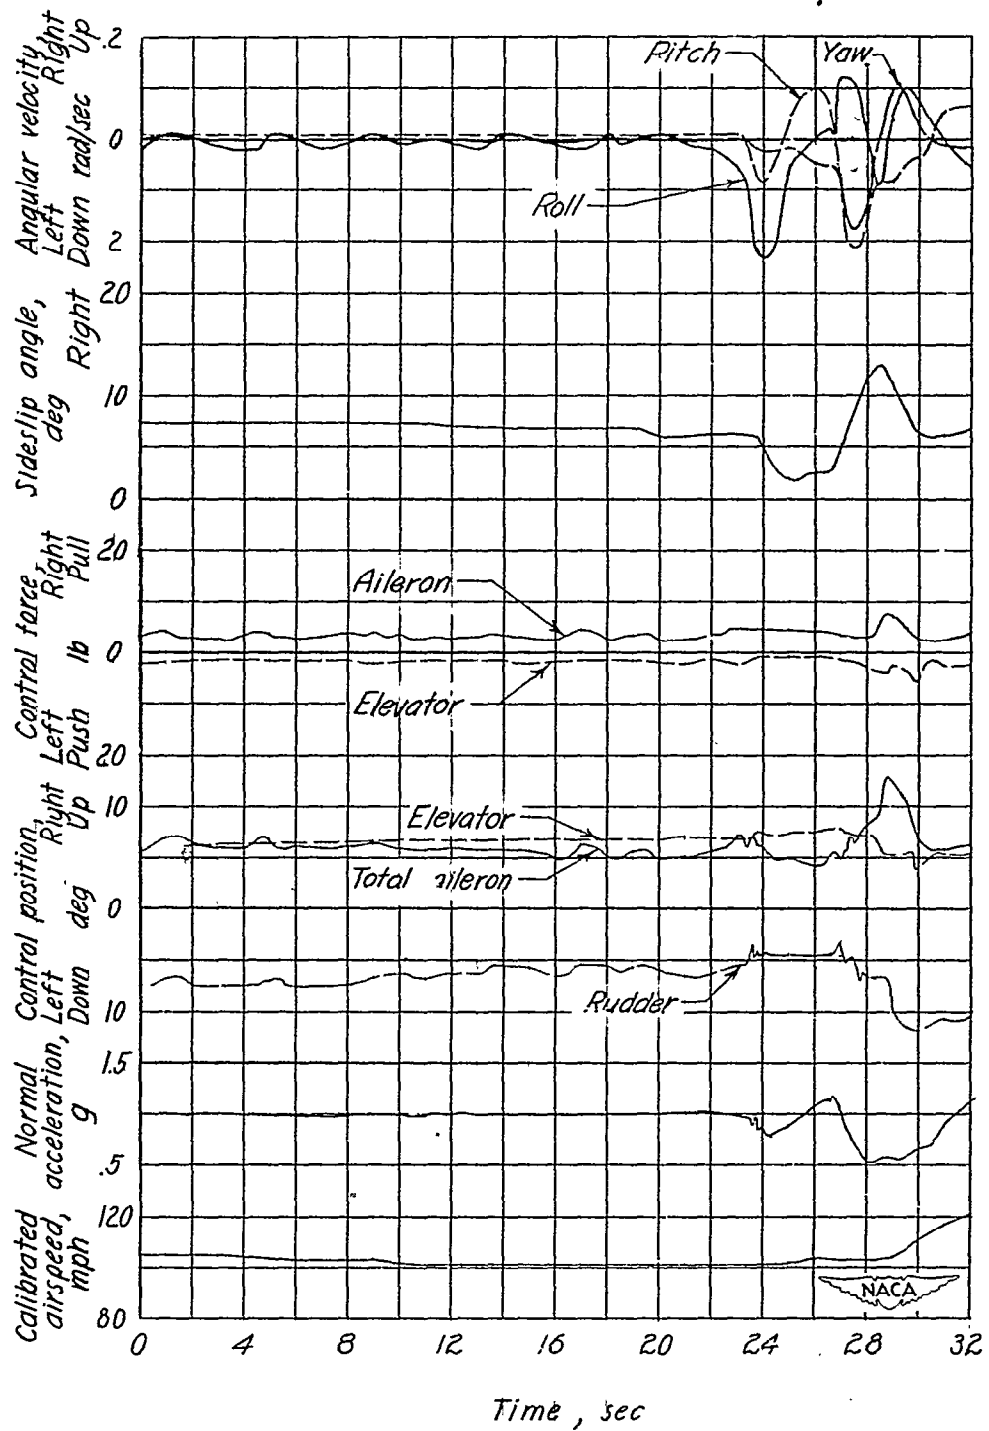
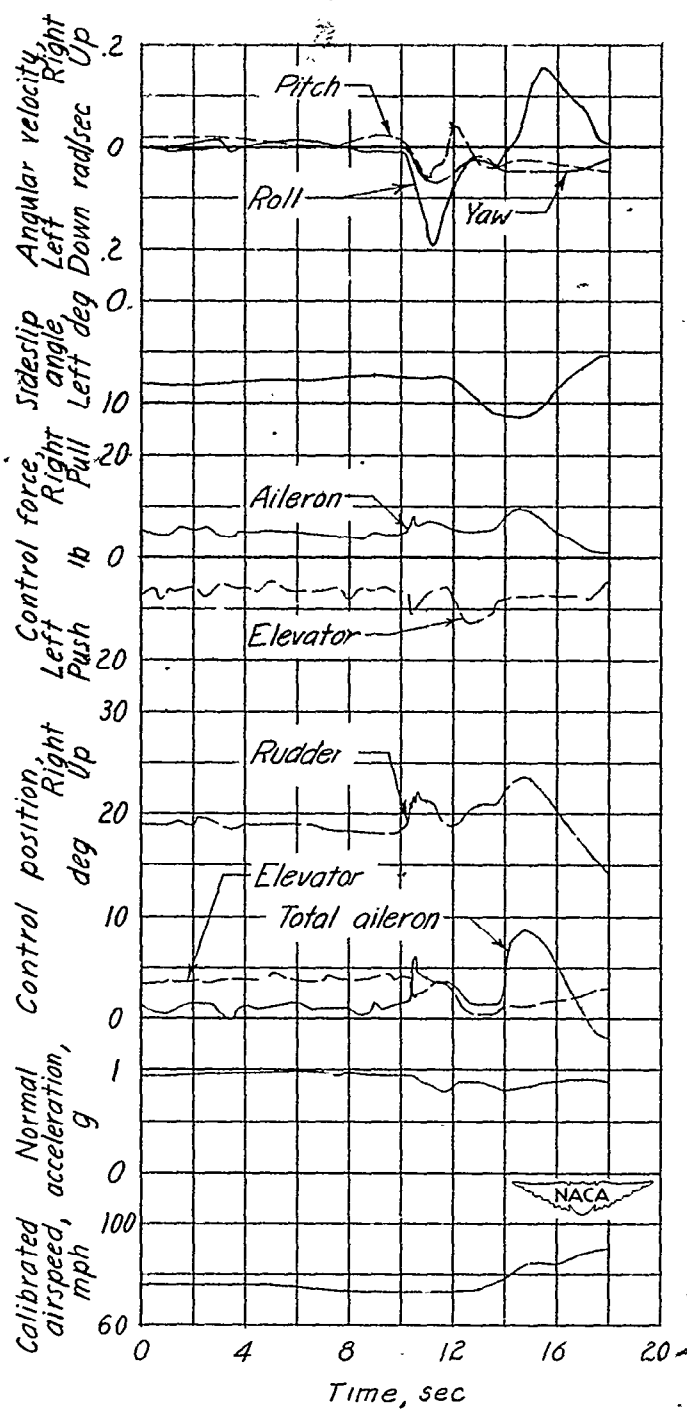
(a) Rated-power clean condition with the center of gravity at 27.1 percent mean aerodynamic chord.

Figure 20. Time history of stalls in the Grumman F8F-1 airplane.

(b) Gliding condition with the center of gravity at 25.7 percent mean aerodynamic chord.

(c) Power-approach condition with the center of gravity at 24.8 percent mean aerodynamic chord.

Time histories of stall approaches and stalls in the rated-power clean, gliding, and power-approach conditions are given in figure 20. The stalling characteristics of the F8F-1 airplane for various configurations were as follows:

1. Rated-power clean (fig. 20(a)). - Stalls in this condition varied somewhat in nature and speed, probably due to differences in sideslip angle and to rate of change of angle of attack during different stalls. In a typical case, however, there was a mild roll to the left which could be easily corrected followed by an abrupt roll to the right. A very steep nose-up attitude gave some stall warning in this condition. The stalling characteristics were considered satisfactory because of the relatively small initial rolling velocity.

2. Gliding (fig. 20(b)). - The elevator control force was in the correct direction but was light. At the stall, the nose dropped abruptly with a sharp roll to the left. The stalling characteristics in this condition were acceptable.

3. Power-approach (fig. 20(c)). - Stalls in this condition were characterized by a mild roll to the left accompanied by mild buffeting. The stalling characteristics were considered acceptable because of their mildness.

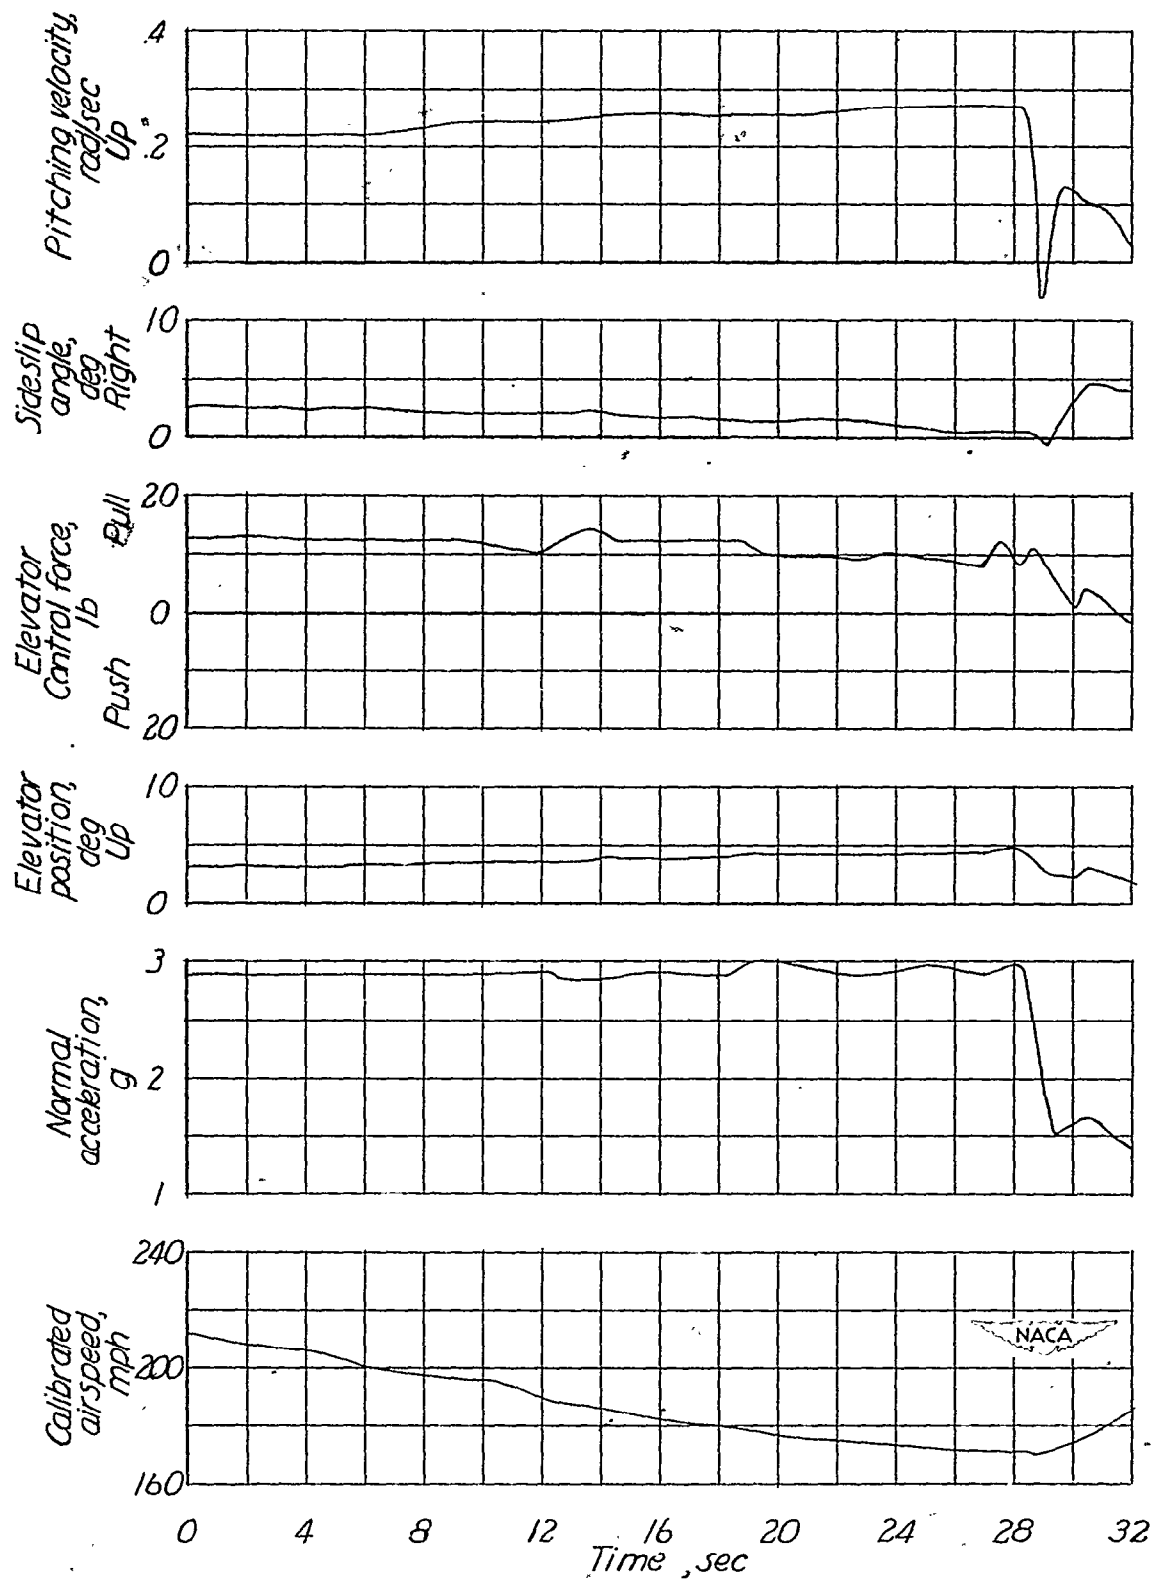
Figure 21.- Time history of a 3g windup turn from 212 miles per hour to the stall in the rated-power clean condition with the center of gravity at 25 percent mean aerodynamic chord. Grumman F8F-1 airplane.

A time history of a 3g wind-up turn to the stall in the rated-power clean condition is shown in figure 21. No warning preceded the stall which was characterized by an abrupt reduction in acceleration and pitching velocity but accompanied by no roll.
